## FINDING THE SOURCE of the FLICKERING LIGHTS

Richard P. Bingham Dranetz-BMI

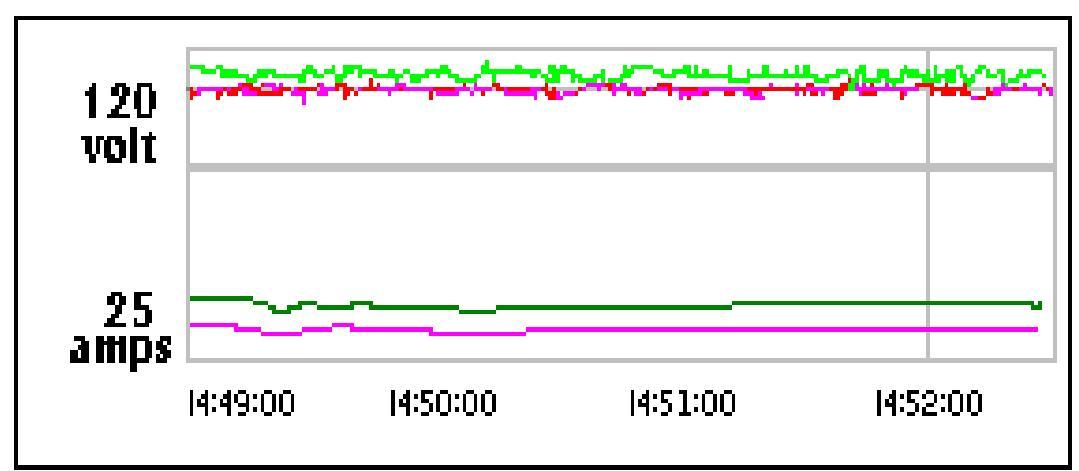
Figure 2 - Timeplot of Voltage and Current.

The source was undetermined, though HVAC units on the roof were suspected. Monitoring was done for only a couple of minutes before the direction of the disturber was determined. The voltage of the one phase varied between 118.3 and 126.3Vrms, while the current varied 23.4-26.8 Arms. Other phase varied from 115.3V-123.3Vrms while the current varied 17.2-19.4 Arms. The load impedance was fairly constant (5 ohms phase A, 6 ohms phase B)

Source impedance was changing significantly (0.4-0.5 variation in ohms on both phases). There was very little change in current levels for the resulting voltage fluctuations. Hence, the disturber was in the direction of the source or voltage

supply side. Since the monitoring was being done at the breaker panel, the source of the flicker was determined to be upstream, or outside the building.

The graph shows the two voltages in the top of the timeplot, and the currents in the bottom of the same plot.

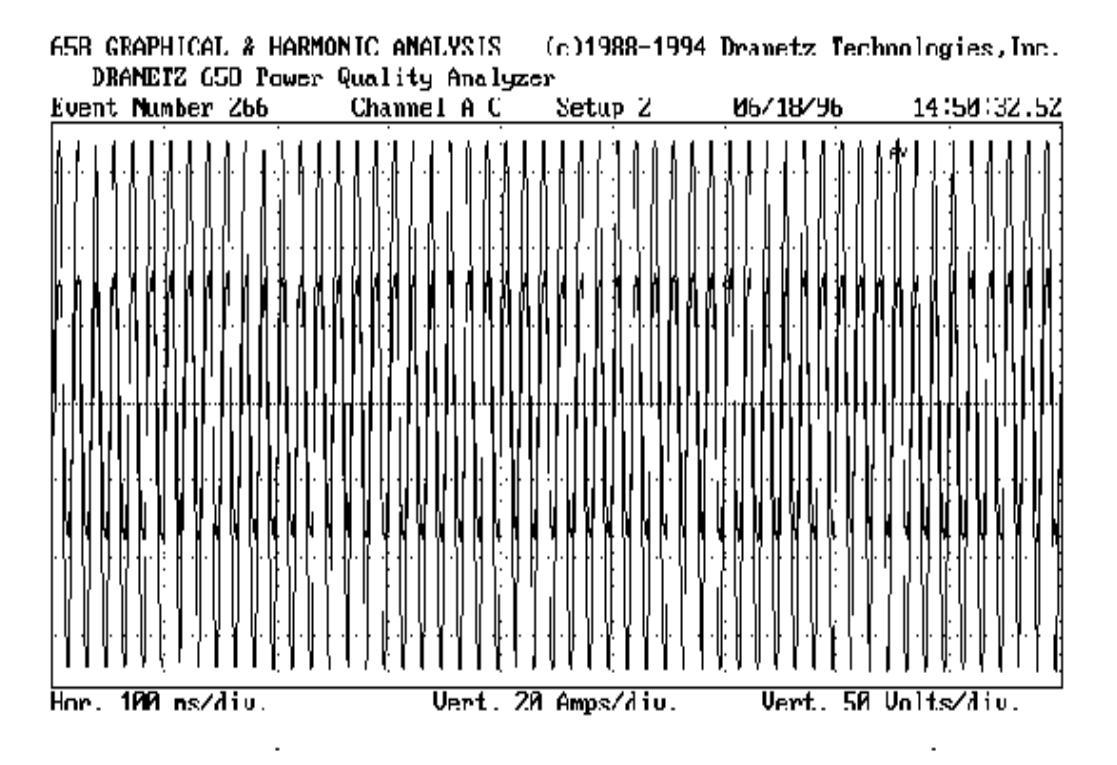
The waveforms of the voltage and current are shown below, with the voltage being the larger waveform. The variation in the voltage waveform is most apparent in the bottom half of the picture.
